Ponding and Blisters – Study of SPF roofs

**Vivek Sharma, Ph.D., Dhaval Gajjar, Ph.D.,
Shima Clarke, Ph.D., PE, AIC, and Stuti Garg**
Clemson University
Clemson, South Carolina

Key Words: ponding, blisters, SPF roof, granular aggregate roof, non-granular aggregate roof.

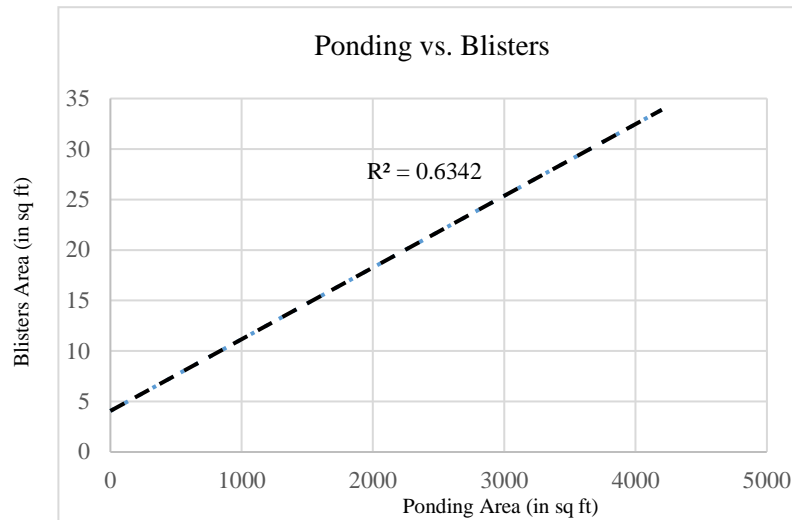
Figure 1. Correlation between ponding & blisters in non-granular aggregate roof (slope less than 1/4")

To investigate whether the area of "Blisters" and the area of "Ponding" were linearly related, a Pearson's correlation coefficient (r) between the two variables was calculated - the result was statistically insignificant. Hence a correlation could not be established between the area of "Blisters" and the area of "Ponding" for non-granular aggregate roofs.
