EPiC Series in Built Environment

Associated Schools of Construction Proceedings
of the 56th Annual International Conference

Case Study of In-Cab Pollutants for Nonroad Construction Equipment

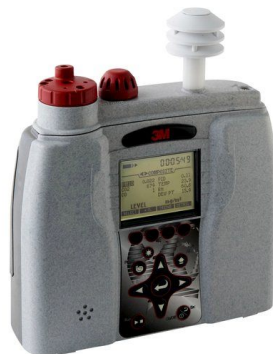
The EVM-7 Advanced Particulate and Air Quality Monitor manufactured by 3M Solutions, as shown in Figure 1, was used for in-cab air sampling (3M, 2019). The EVM-7 measured pollutant concentrations of CO, CO₂, and PM_{2.5}. With all dimensions less than 20 centimeters and weighing less than 1.5 kilograms, the unit was compact and light enough to be easily placed and secured inside the cabs of the equipment without interfering with the operator's activity. Battery life of the monitors was at least eight hours in running mode; however, throughout the data collection process, up to 12 hours of battery life was possible without another power source, making it possible to measure pollutants for a complete eight-hour workday.

Figure 1. EVM-7 advanced particulate and air quality monitor

The EVM-7 sensor had specific calibration requirements. The particulate sampling filter was calibrated using a factory provided zero-calibration filter. The pump flow rate was calibrated by a standard flowmeter calibrator. The flow rate was adjusted to 1.67 liters per minute per the manufacturer. For CO and CO₂, two limits were needed for calibration: zero (minimum) and span (maximum). For setting the zero limit, a nitrogen (N₂) calibration gas cylinder, which contained zero parts per million (ppm) of CO and CO₂, was used. For identifying the maximum limit, a CO sensor calibrated by a 100 ppm CO gas cylinder and a CO₂ sensor calibrated by a 100 ppm CO₂ gas cylinder were used. During the data collection process, each sensor was calibrated on a regular basis as prescribed by the manufacturer. Table 1 shows the standards regarding the accuracy, precision, and display range for the EVM-7 (3M, 2019).

To gain the most accurate data, the monitor was placed as close as possible to the breathing zone of the operator (near the nose and mouth). For the purposes of the case study, the entire in-cab area of the equipment was considered the representative operator personal exposure area. The monitor was secured inside the equipment cab in locations near the operator, such as behind the operator's seat, the rear corner of the cab, or an open side storage compartment. The monitor was never concealed in a manner such that it did not have access to the breathing zone of the operator. The typical equipment operator workday started at 7:30 am and ended at 4:30 pm, with a lunch break from 11:30 am to 12:30 pm. The monitor was placed in the targeted equipment cab between 7:00 am and 7:30 am and removed after 5:00 pm to collect data over the entire workday. Data were collected and logged in 30 second increments over the course of the workday.
